Philmont Scout Ranch		Title: PTB Style Red Roof Inn	
	Red Roof Inn V3		Tolerances: N/A	
Drawn by: Ronald La Curan		N/A		Index: N/A
Date: 10/06/08	Scale: 1:50	Version: 1		Page 1 of 38

Red Roof Inn V3

Red Roof Inn Lumber Requirements and Cost Estimate

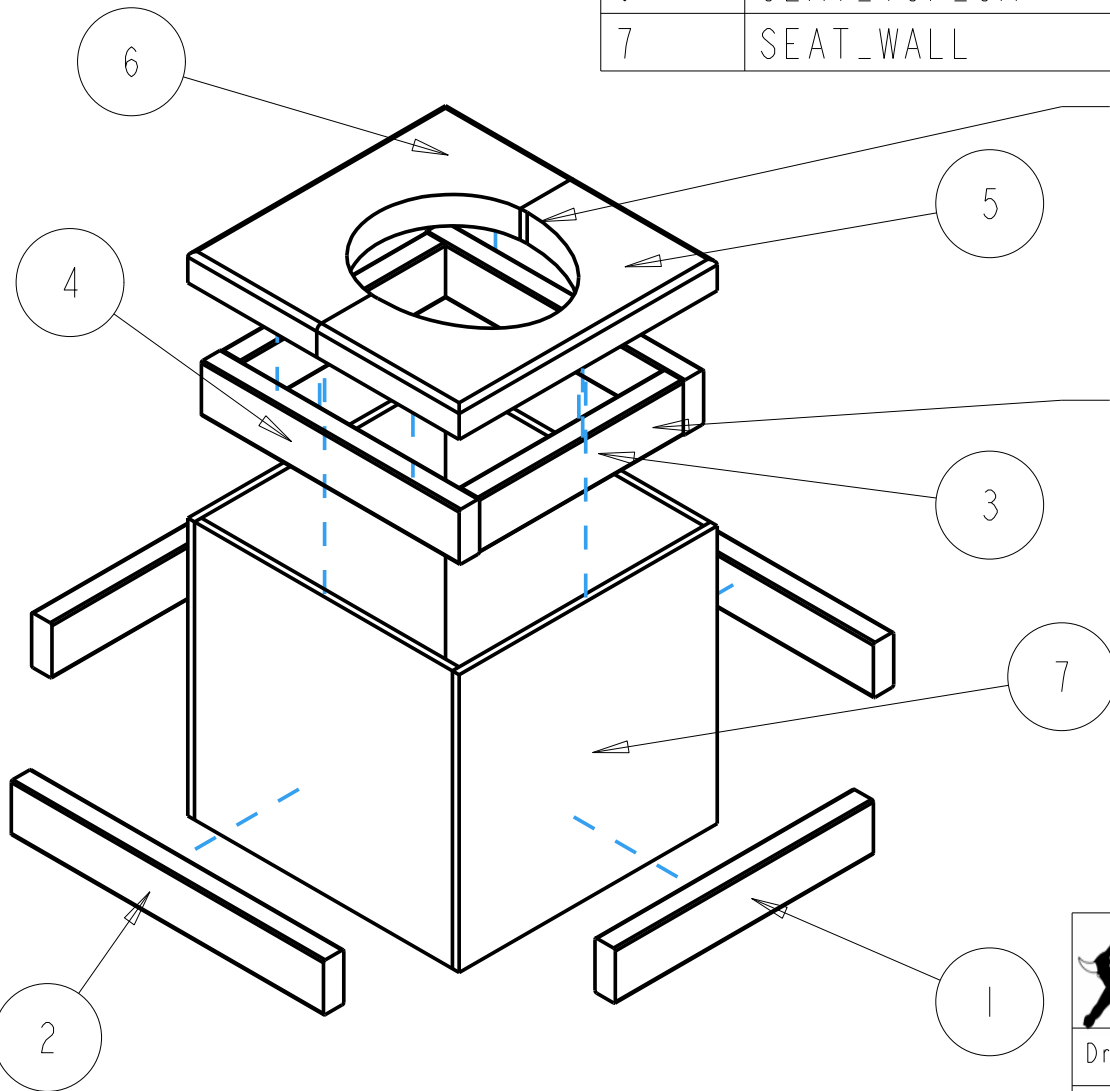
Philmont Scout Ranch	Title: TOILET_SEAT EXPLODE	
	Red Roof Inn V3	Tolerances: ± 0.25	
Drawn by: Ronald La Curan	SPF	Index: 16	
Date: 10/06/08	Scale: 1:10	Version: 1	Page 25 of 38

Center toilet seat on the top of the structure and trace the inside of the ring with a marker. Use a chainsaw to cut out the shape of the hole and then attach the toilet seat lid.

The framing composed of parts 3 and 4 should sit flush with the top of the box composed of part 7.
